SIB 61 07 21

2021-09-08

NOISES FROM THE STEERING SWITCH CLUSTER AREA

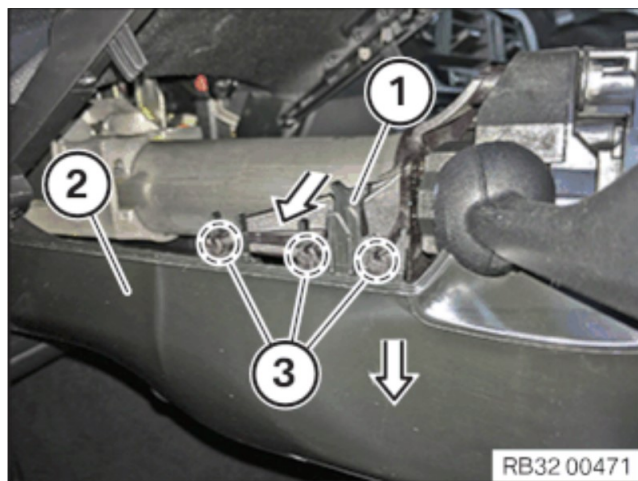
<p>1. Disassemble the steering column shroud as per REP 32 31 020 (included in 61 31 008) Removing and installing lower part of steering column shroud and turn the steering wheel from one limit position to the other while stationary.</p> <p>Is the noise still present?</p>
--	---

No: Mount the steering column shroud correctly according to the repair instructions and turn it to test whether the noise is still present.

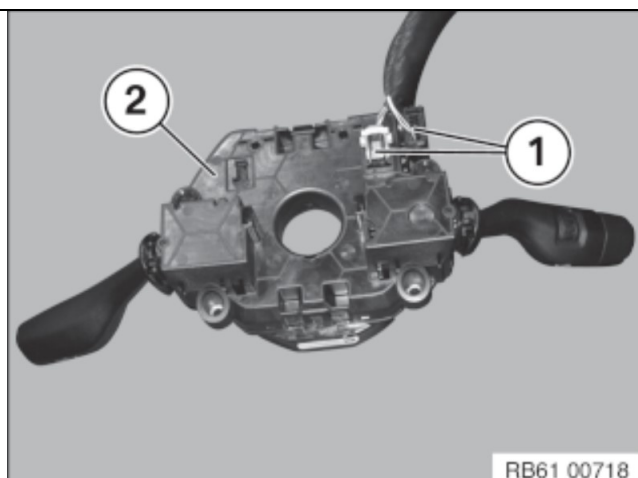
2. Disassemble the steering wheel and remove the steering column switch cluster (SZL) (2) as per **REP 61 31 008** Removing and installing steering column switch cluster

Re-install the steering wheel without the SZL according to repair instructions and turn the steering wheel from one limit position to the other while stationary.

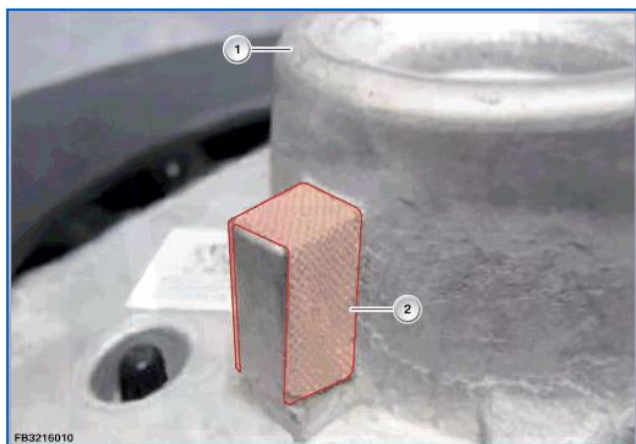
Check whether a sliding tape is bonded on the drive flange on the steering wheel.

If adhesive tape (white or black) is affixed on the drive flange on the steering wheel, remove it and clean the bonding surfaces (2) with safety solvent cleaner (P/N 83 19 2 451 316).
